SUBJECT: Operational Report - Lessons Learned, Headquarters, 1st  
Battalion, 63d Armor, Period Ending 31 October 1967

DEPARTMENT OF THE ARMY  
HEADQUARTERS, 1ST BATTALION 63D ARMOR  
Fort Riley, Kansas 66442

SUBJECT: Operational Report - Lessons Learned RCS CSFOR-65

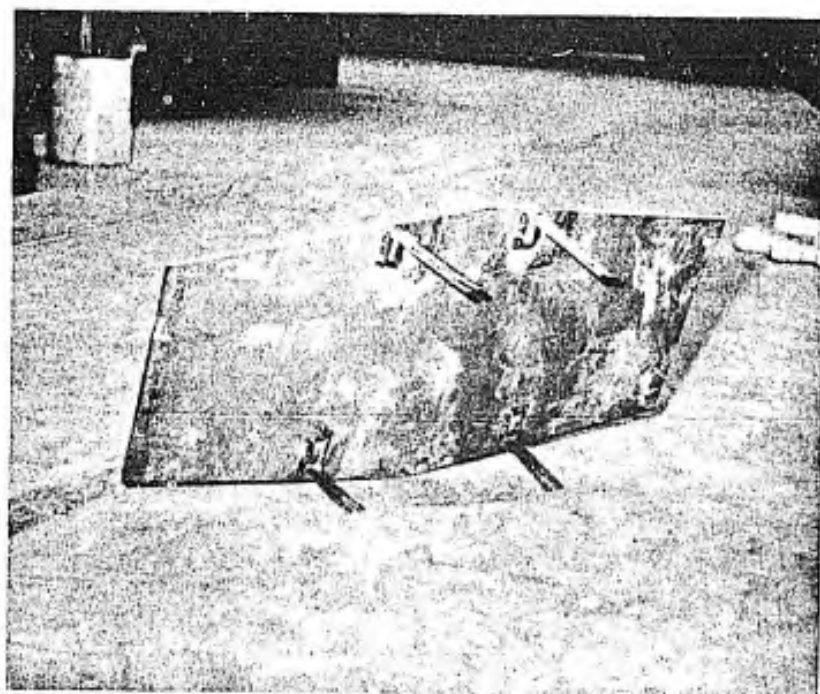
PICTURE OF UNIT-MADE SECURITY SHIELD

4. Intelligence and Security: When it becomes necessary to remove the gun tube and mantle, the tank is no longer a classified container. The unit has fabricated a metal shield bolted from the inside to alleviate this problem. A picture of the shield is included as Annex D.

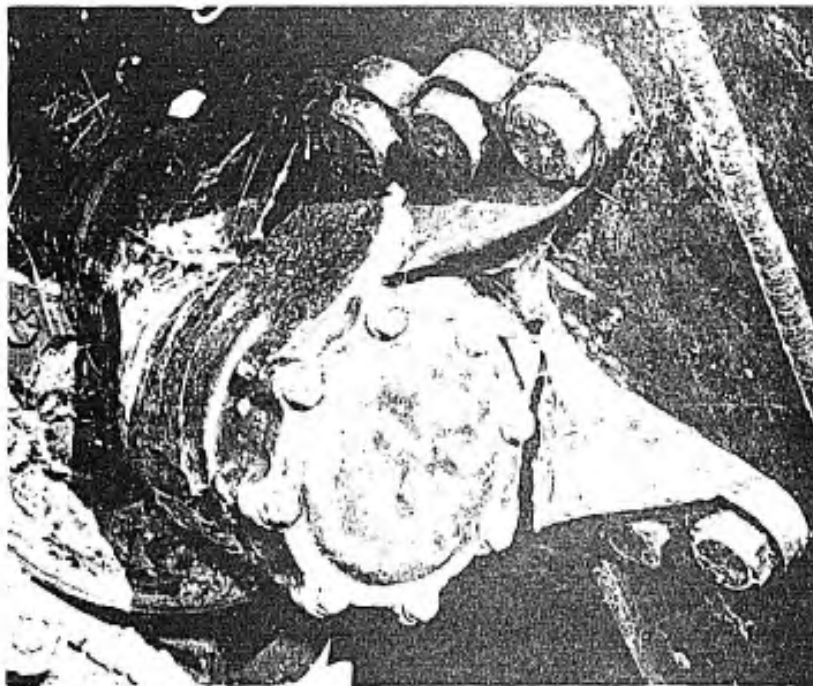
ANNEX E

(b) Idler Assembly: See Annex E.

(1) Broken Idler Assembly - Section I, paragraph 6b(2)(b) of basic report and Annex E.

SUBJECT: BROKEN IDLER ASSEMBLY

The first instance of a broken idler assembly occurred on 11 October 1967. At the time for the damage, the vehicle was traveling at approximately five (5) miles per hour, under conditions of darkness when the right track struck a stump.

In addition to the damage illustrated below there was a slight dent in the right side of the hull immediately to the rear of the Idler assembly. The corner of the hull under the assembly was also dented.

The broken Idler arm assembly was sent to the factory for analysis.
